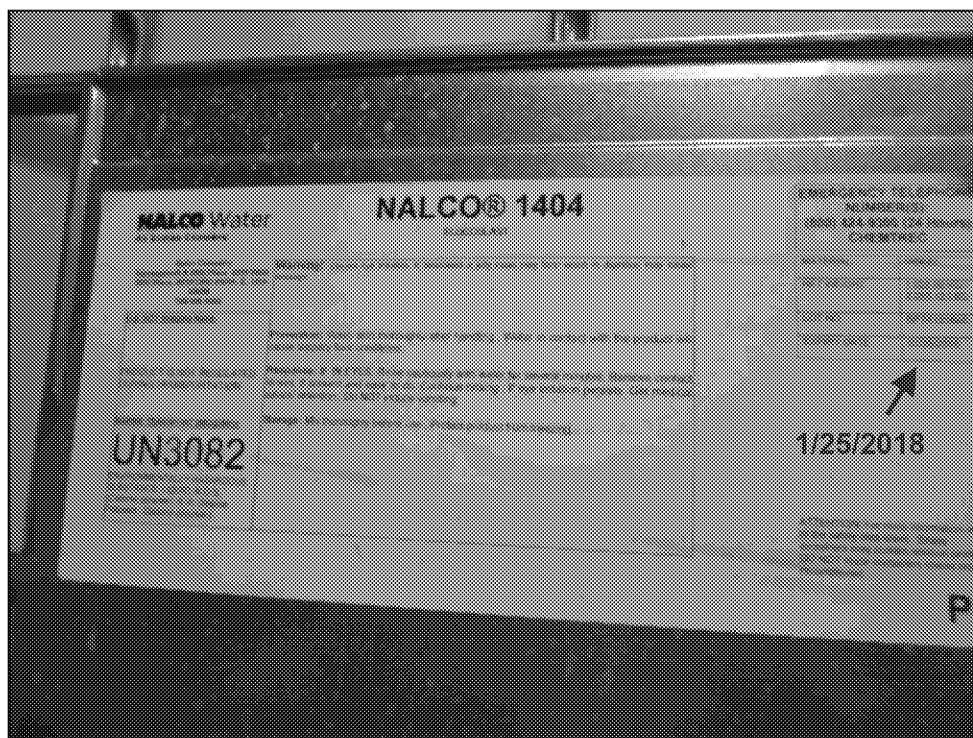
Photograph 5. View of the flocculant stored in the pretreatment building. The expiration date noted on the label was January 25, 2018.

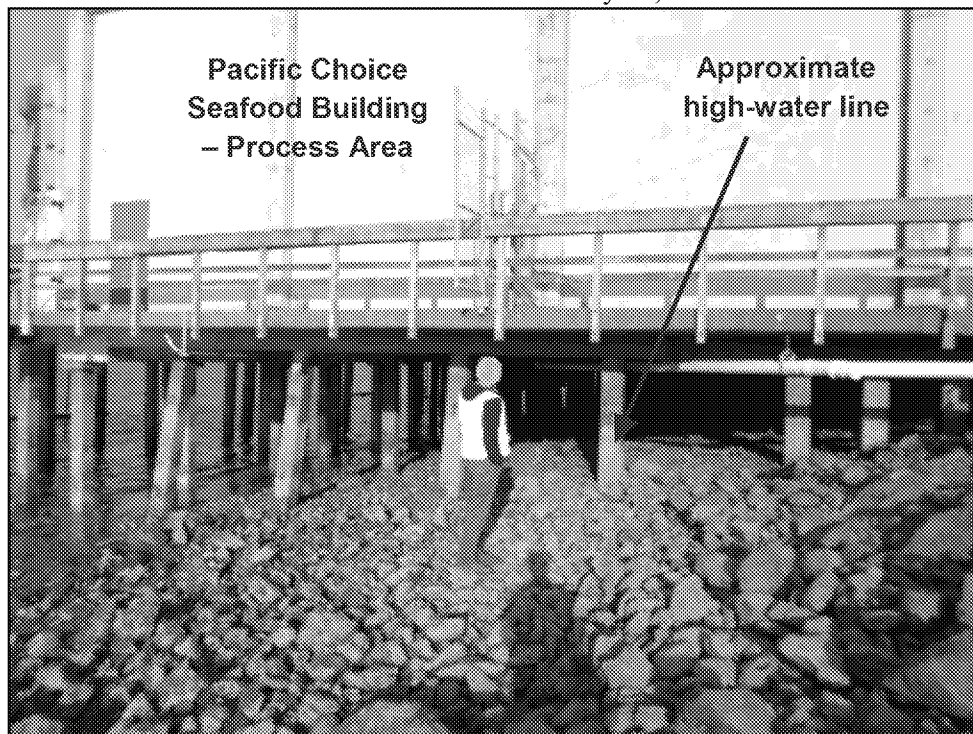
Photograph 6. View, facing east, of the west side of Pacific Choice Seafood. Note approximate high-water line showing the extent of the tidal influence.

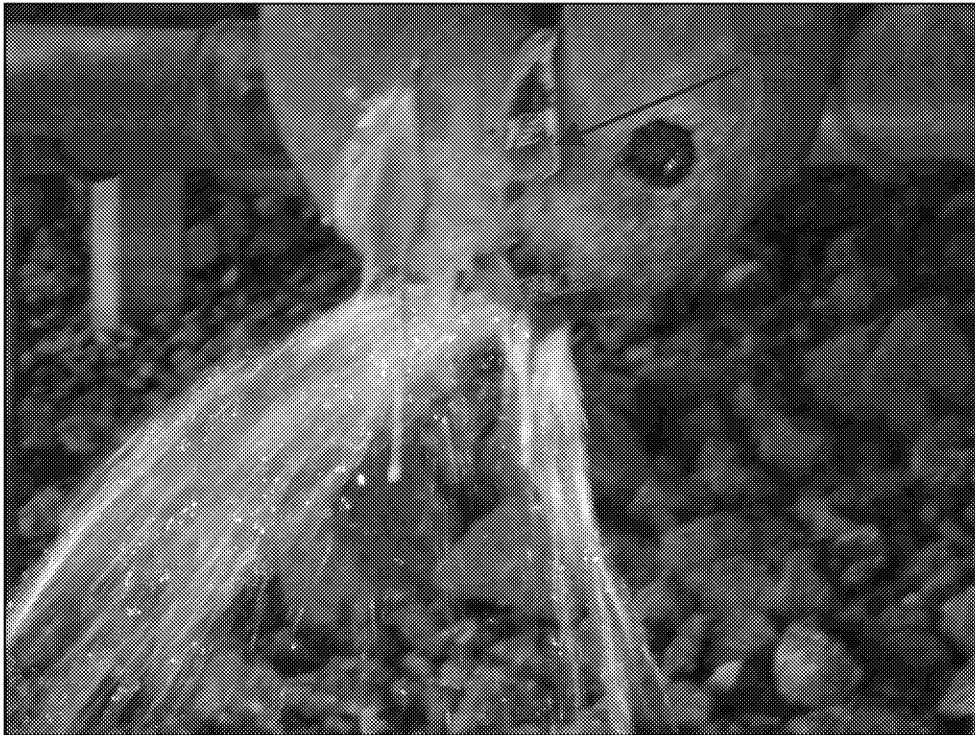
Photograph 13. Close-up view of leaking pipe shown in foreground of Photograph 12. Black tape was present on the pipe.
